## Coal Mine Fatal Accident 2003-19

Operator:	Uptown Motors, Inc.
Mine:	Guthrie Creek Mine
Accident Date:	June 26, 2003
Classification:	Powered Haulage
Location:	District 11, Parrish, AL
Mine Type:	Surface
Employment:	35
Production	900 tons/day

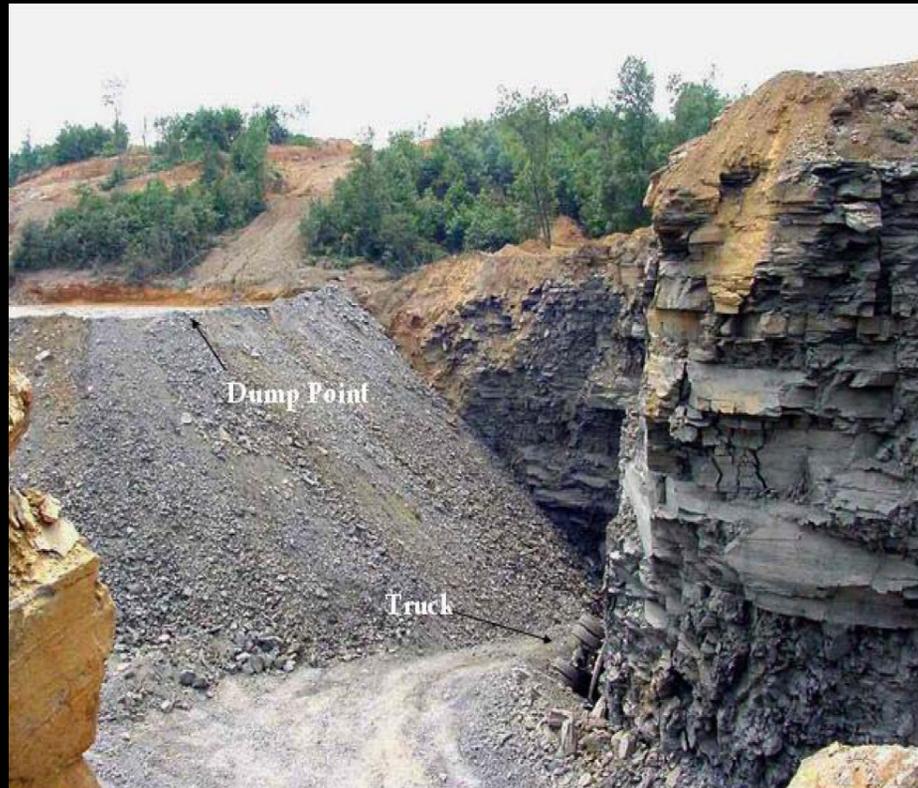
- While in the process of backing the loaded rock truck towards the edge of the dumping point, the truck overtraveled, went down the spoil embankment, struck the highwall at the bottom of the spoil, and overturned.
- Between 7:05 a.m. and 7:10 a.m. a second truck driver saw the victim's truck wrecked at the bottom of the spoil pile and called for help on his CB radio and informed the rest of the crew of the accident.

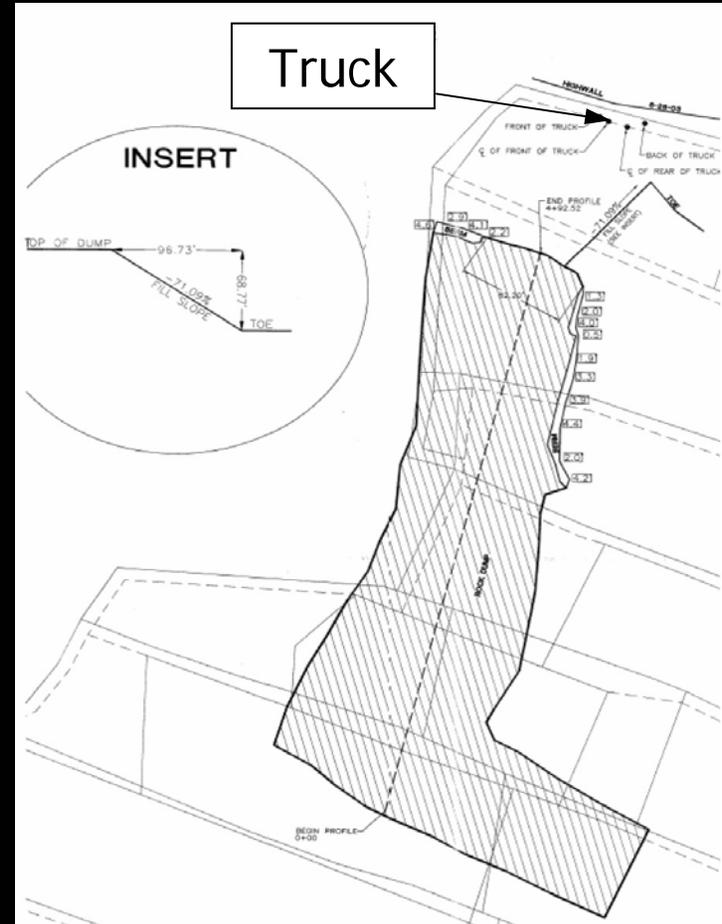
- The section of the pit where the accident occurred was being filled in by spoil material. A total of 5 rock trucks were dumping at this location on the morning of the accident.
- The victim hauled an unknown number of loads of spoil on the morning of the accident. The load trip counter on his truck had not been reset prior to the start of his shift. The other trucks that were dumping at this location that morning had trip load counts that indicated 5-7 loads had been dumped up to the time when the accident was discovered.
- The truck traveled backwards down a 71% grade for ~119'. The truck's parking brake system was not applied and the transmission was in the reverse gear position.

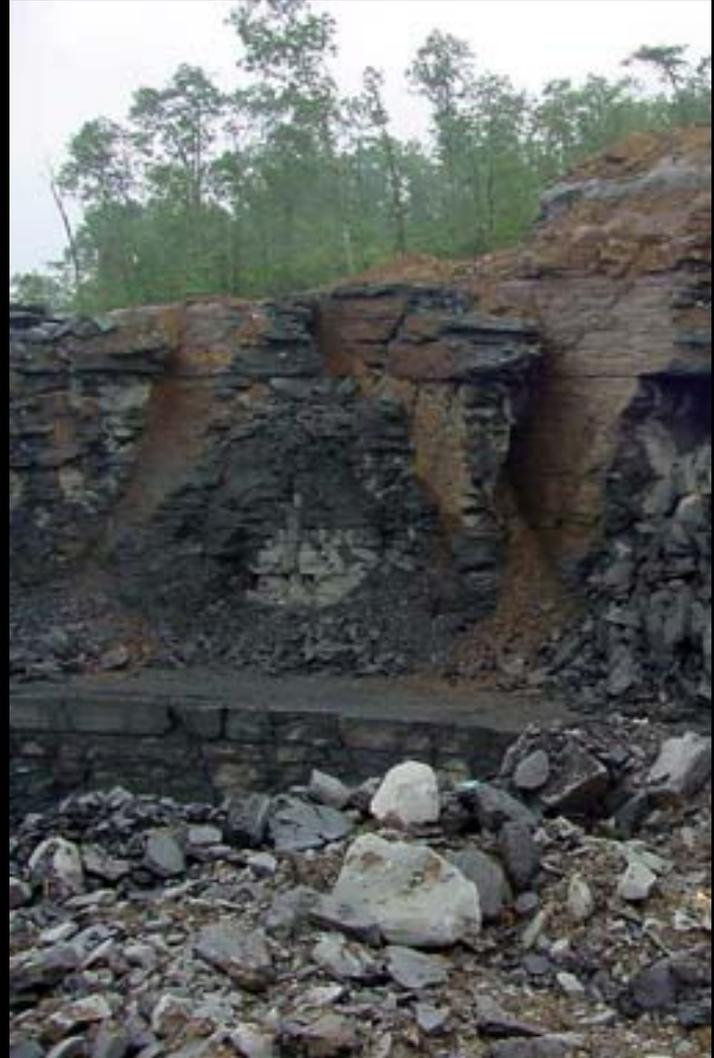
- There was no berm provided at the edge of the 001 Pit Dumping point for 82'.
- The daily on-shift examination record showed no hazardous conditions recorded for the 001 Pit Dumping location.
- 30 CFR 77.1713(a) requires the operator to correct hazardous conditions, such as the lack of berms at active dumping locations, identified during such examinations.

*Causal Factor:* A berm was not provided at the edge of the 001 Pit dumping point to prevent overtravel or overturning.

*Corrective Actions:* Dumping location practices and procedures should be reviewed to ensure that the dumping process does not create hazards to persons that are required to work in those areas.

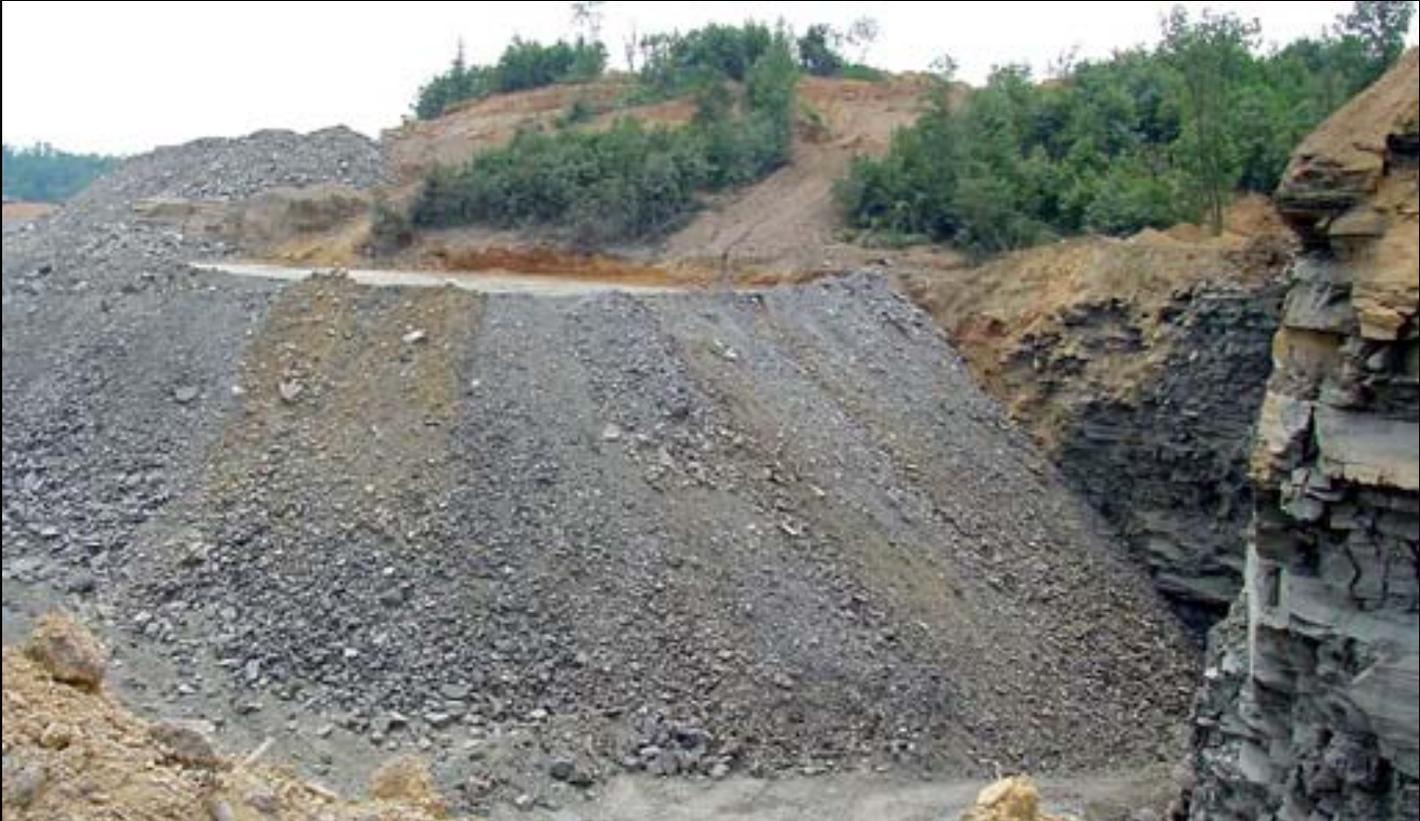
- There was no indication of ground failure at the edge of the dumping point that would have destroyed evidence of any berm that may have existed prior to the accident.
