Double Insulated Drill Tests

Informational Report 1081

DOUBLE INSULATED DRILL TESTS

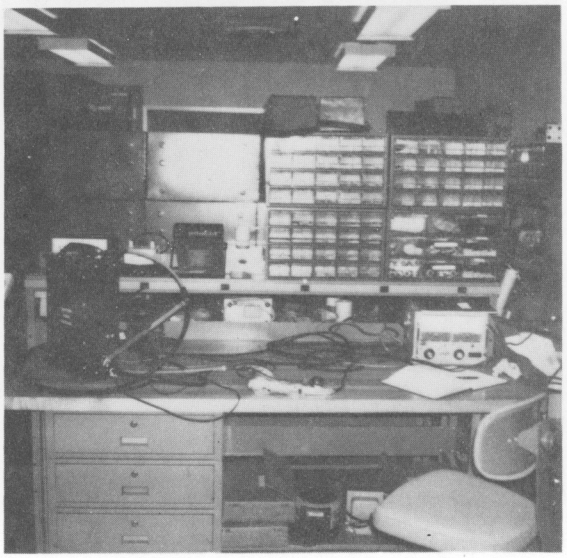
FIGURE G-2. - Dielectric withstand test, 3-2-76.

Figure G-2 shows the drill undergoing the dielectric withstand test.

The above readings indicate that the insulation system on the new drills is very good. At the above voltages, the insulation system did not break down. The breakdown voltage was not determined since this would have destroyed the insulation of the drills.

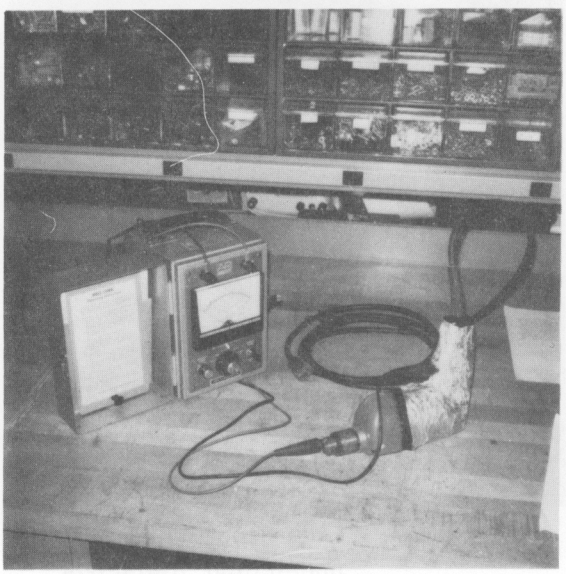
FIGURE G-4. - Insulation resistance test, 4-13-76.

As can be seen from the above test results, the drill's insulation system integrity was not adversely affected by heat and humidity.

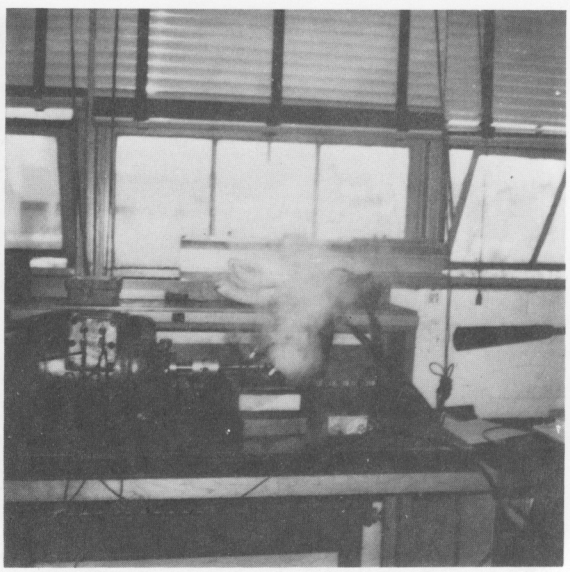
FIGURE G-11. - Drill smoking when loaded to 3.6 amps, 3-15-76.

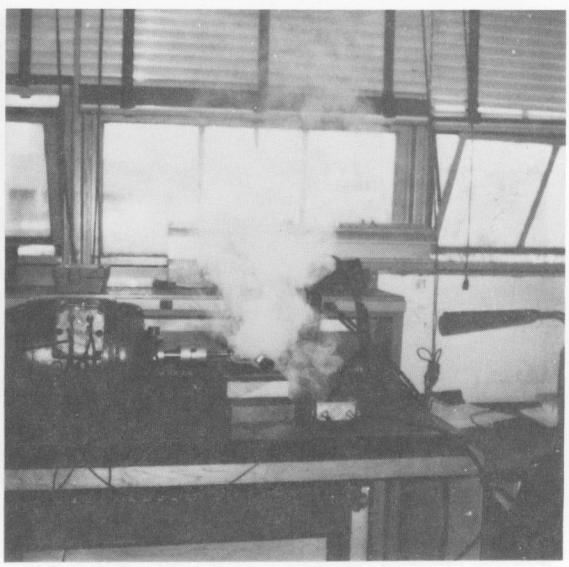
Time	Drill loading
9:24 a.m.....	Started running, no load.
9:50 a.m.....	Full load, 3 amps.
10:05 a.m.....	Loaded drill to 3.3 amps.
10:35 a.m.....	Loaded drill to 3.6 amps.
11:05 a.m.....	Loaded drill to 3.9 amps.
11:13 a.m.....	Drill D burned out and burst into flame.

FIGURE G-12. - Drill burning out when loaded to 3.9 amps, 3-15-76.

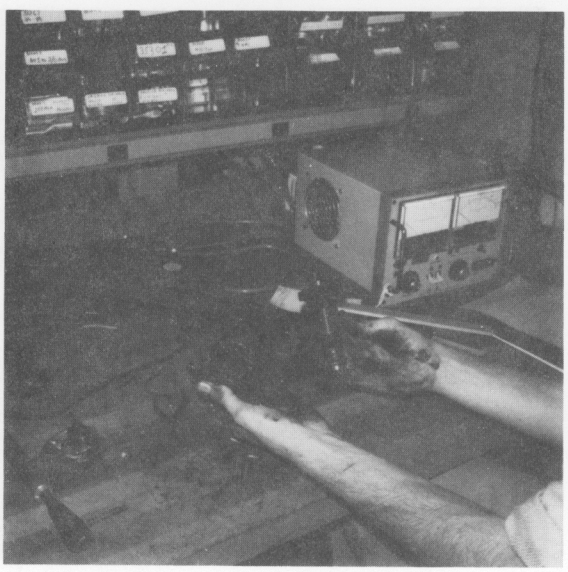
FIGURE G-15. - Disassembled, overloaded coal-conditioned drill, 3-15-76.
