Application of the RACAL Airstream Helmet in Four Underground Coal Mines

Paul S. Parobeck,[A] William J. Francart,[B] Robert S. Ondrey,[C] Richard T. Stoltz,[C] David J. Atchison,[D] and Everett J. Gerbec[D]

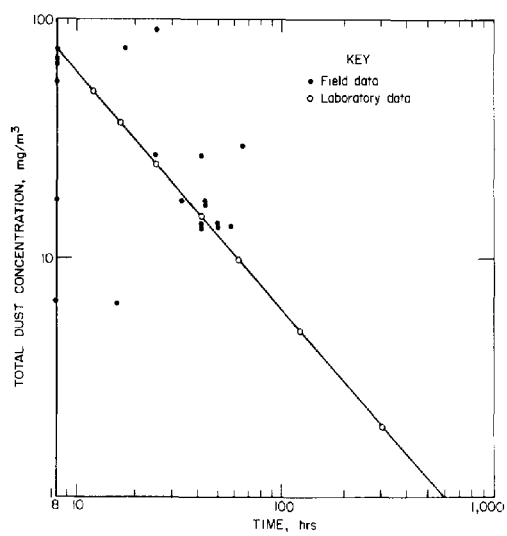
FIGURE 5. Filter life versus total airborne dust exposure.

The estimated loading of filters that were changed was compared to laboratory data established for estimating the life expectancy of the filters.[1] This comparison is shown in Figure 5. Thirteen of 20 data points are in close agreement with the established laboratory data. Although the actual reasons for four of the filters lasting longer than expected and three not lasting as long as expected are unknown, it should be noted that the variation in the concentration and particle size distribution of dust underground can be considerably different than that generated in the laboratory. Additionally, in the laboratory study, the helmet was operated continuously until the final filter was loaded with dust; during the field study the helmets were often turned off when the longwall was not operating and also during travel time. One reason the field and laboratory data differ could be that field data points plotted in Figure 5 represent full-shift time (8 hours), while in reality actual helmet operating time was unknown.

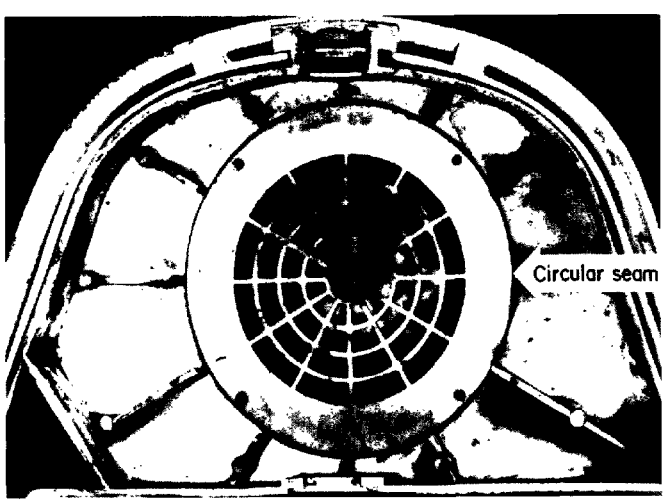
FIGURE 6. Motor housing assembly on RACAL Airstream Helmet.

In addition to the problems associated with wearing the helmet, there were problems with the use of the air flow indicator disc which prevented its use in some cases. One such problem developed because of a ridge around the motor housing assembly of some helmets. The motors of these helmets had been repaired and when the motor assemblies were inserted into the helmets, the circular seam, shown in Figure 6, between the helmet and the motor housing was sealed with a hot iron. This produced an irregular ridge which would occasionally cause the air flow indicator disc to "hang up" and remain on the helmet after the fan motor had been turned off. Therefore, care had to be taken to ensure the air flow indicator disc did not "hang up" on these ridges, giving a false indication of the status of the final filter.

cator disc was that some motor housing assemblies had convex rather than flat surfaces. This prevented the air flow indicator disc from seating properly (lying flat) on the motor housing assembly. Consequently, the air flow indicator disc would always fall off the motor housing assembly, even when testing a newly installed final filter.
