## Coal Mine Fatal Accident 2003-19

Operator:	Uptown Motors, Inc.
Mine:	Guthrie Creek Mine
Accident Date:	June 26, 2003
Classification:	Powered Haulage
Location:	District 11, Parrish, AL
Mine Type:	Surface
Employment:	35
Production	900 tons/day

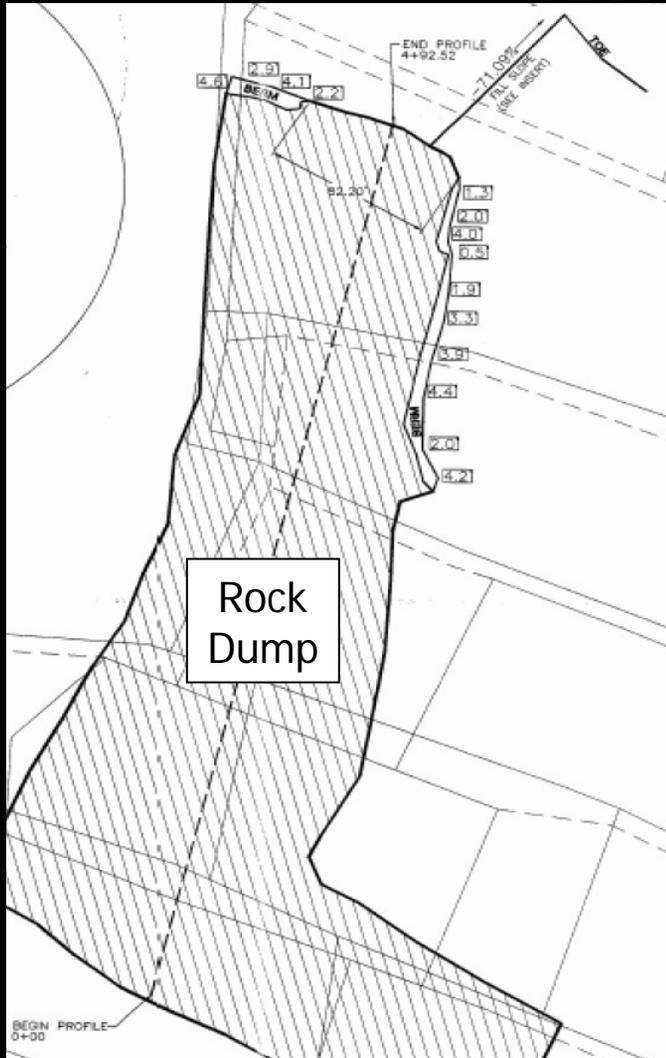
- The round trip distance from the pit to the dumping location was approximately 3/8 of a mile.
- The victim made an undetermined number of trips to the dumping point location.
- The road conditions were dry and the weather was clear.
- The dumping location approach measured ~112' in width, 492' in length, and had an uphill grade of 2%.
